**NATIONAL TRANSPORTATION SAFETY BOARD**  
Vehicle Recorder Division

## **Cockpit Voice Recorder**

**Specialist's Factual Report**  
**By Bill Tuccio, Ph.D.**

Location: Italy, Texas  
Date: July 6, 2016  
Aircraft: Bell 525, Registration N525TA  
Operator: Bell Helicopter  
NTSB Number: DCA16FA199

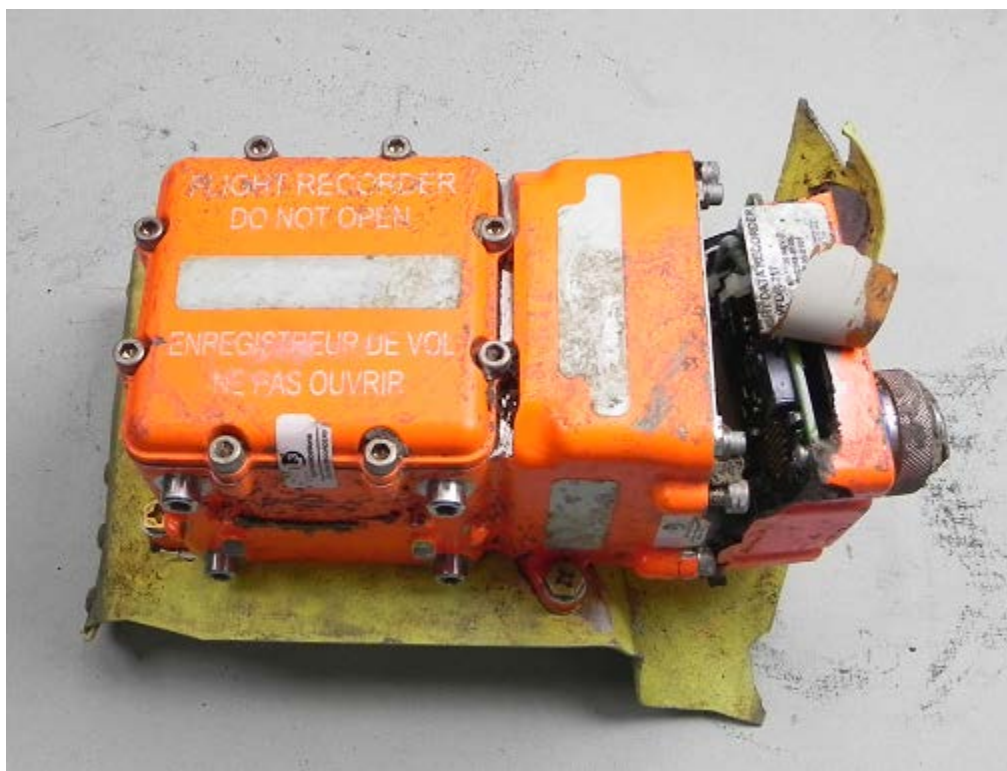
Upon arrival at the laboratory, it was evident that the exterior of the CVFDR had sustained significant structural damage, as shown in figure 1. The outer case was removed and the interior crash-protected case did not appear to have any heat or structural damage, as shown in figure 2. The memory board within the crash-protected case was checked for heat or structural damage and none was found, as shown in figure 3. The digital audio was successfully downloaded from the crash-survivable memory using hardware and software provided by the CVFDR manufacturer.

**Figure 1. L3 CVFDR as received.**

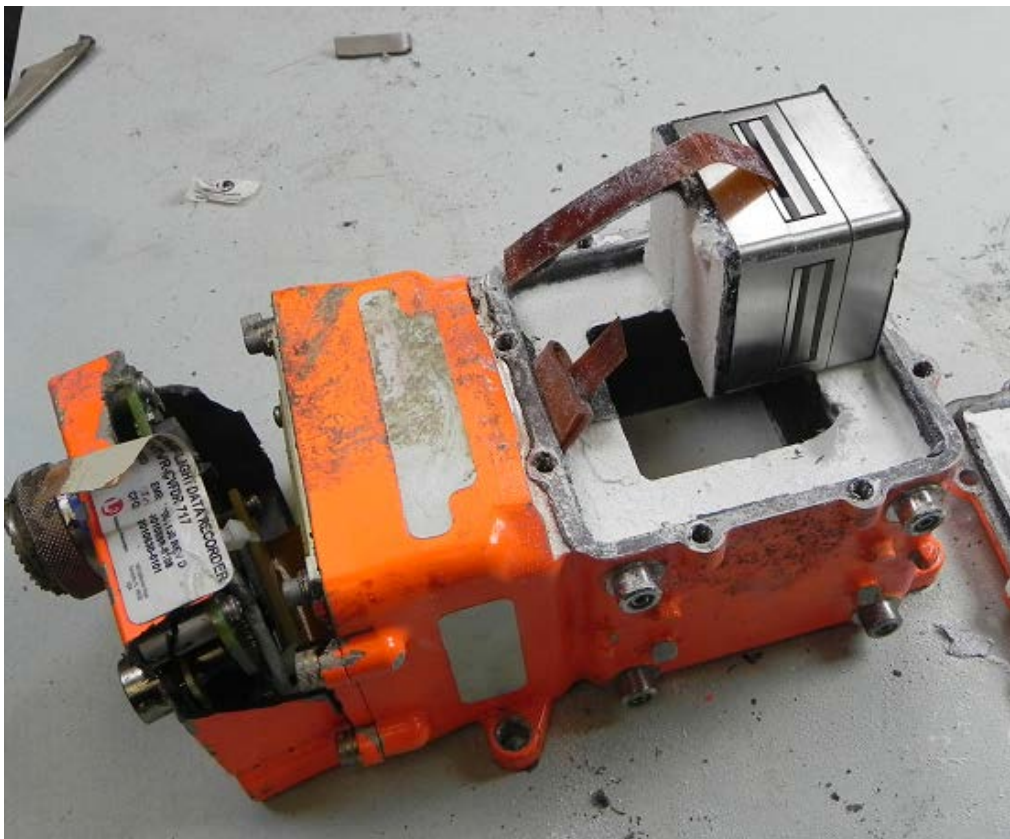
**Figure 2. Crash survivable memory unit removed from unit.**

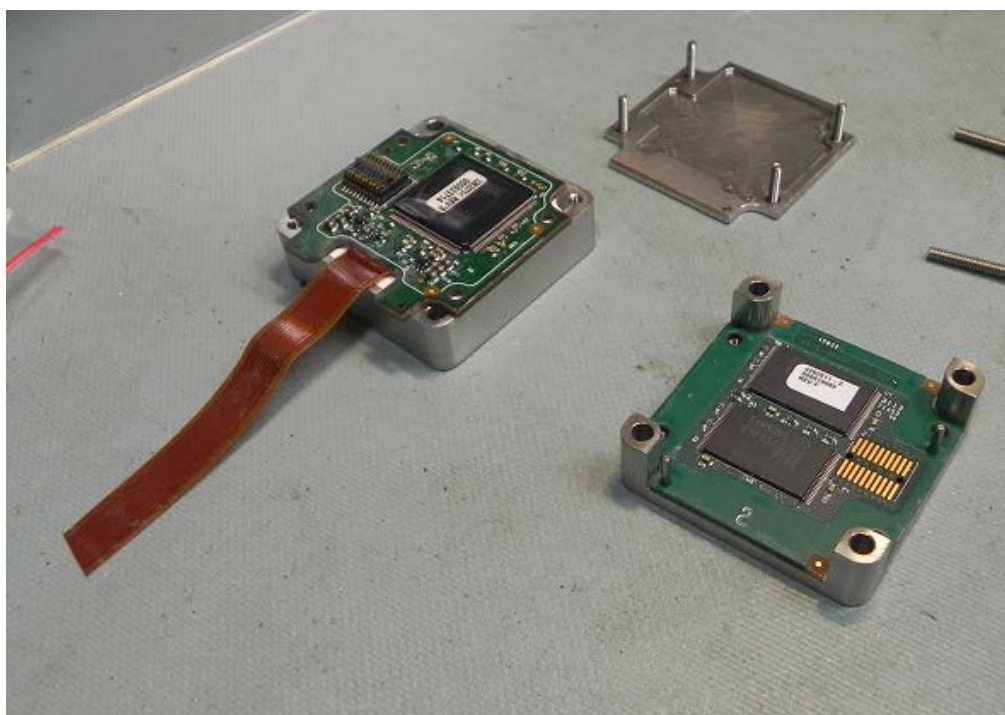
**Figure 3. Component and memory board inside crash survivable memory unit.**
